Solicitation #: IFB B22017

Addendum Title: ADDN 2: UNIT AVAILABLE TO VIEW; DEADLINE DATES; CHESTNUT REPORT

Re.: 1601 Chestnut, Henderson, NV  
Innova 121-167-002  
**Carport Support Beam**

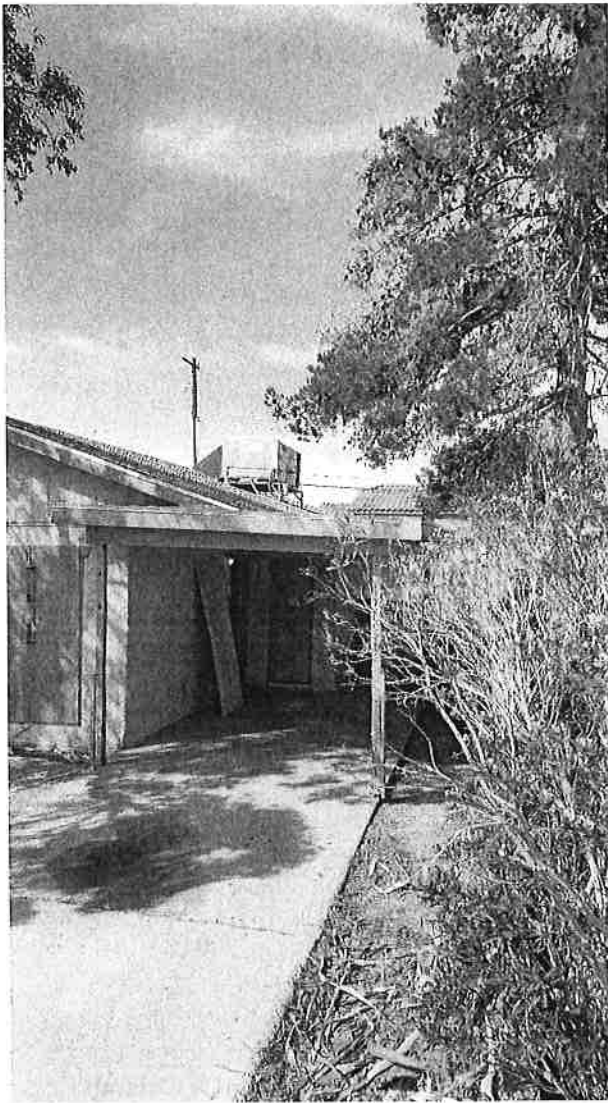
There is a single vehicle carport approximately 10' x 18' in size. It is built into a notch in the north corner of the house at 1601 Chestnut. It is made of wood and appears to be constructed with the original building which was constructed in 1981. It has a gently sloping monoslope roof and is supported by three 4x4 wood columns and is attached to the house basically on one side. The roof is plywood on top of 2x4 rafters. The rafters span from the house to an outboard edge timber. This outboard timber has a nominal size of 4x10 spanning across the top of two columns. This timber has developed a 20-degree twist over the years as it has dried. Most of this twist is at the SW corner.

Photo 1 – General View of Carport looking Southwest

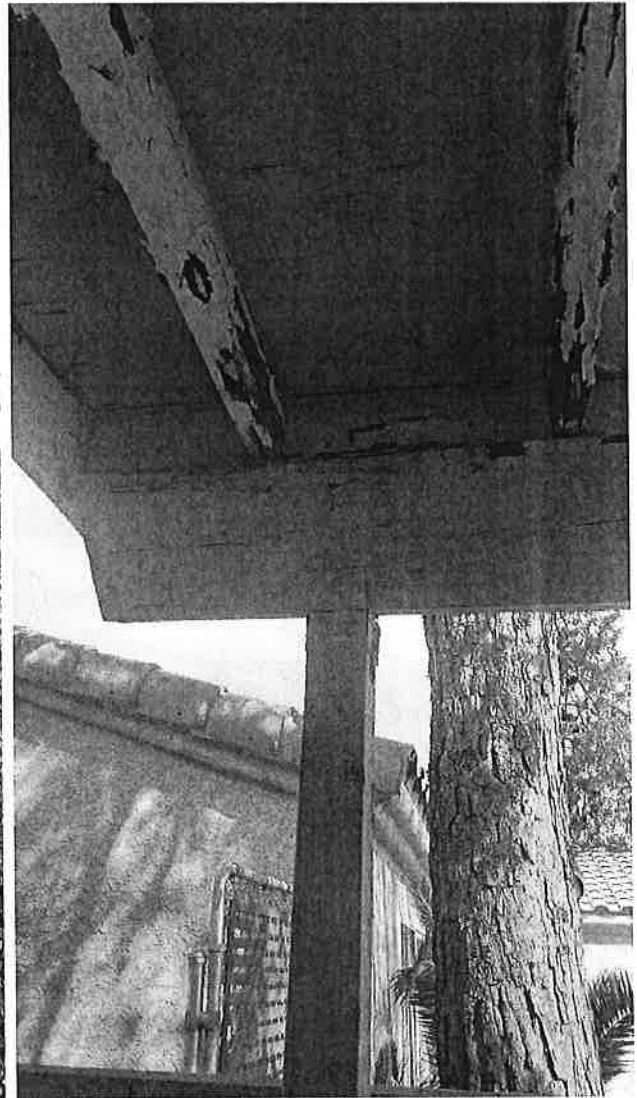
Because of the way the members stack on top of each other, which then stack on top of the column, there is a basic instability under vertical load. Calculations show that it is stable under light dead load, which it currently supports. However, it is not stable under full Code required dead plus live load. In addition, it appears there may be inadequate connection between the roof rafters and the timber, as there are only a few toenails holding it together.

Photo 2 – Side View of Timber on Top of Column.

1. Temporarily support the carport roof.
2. Remove and replace north column, including bottom connection hardware.
3. Remove and replace support timber, including column to timber connection hardware at both columns.
4. Add stronger connections between rafters and timber.

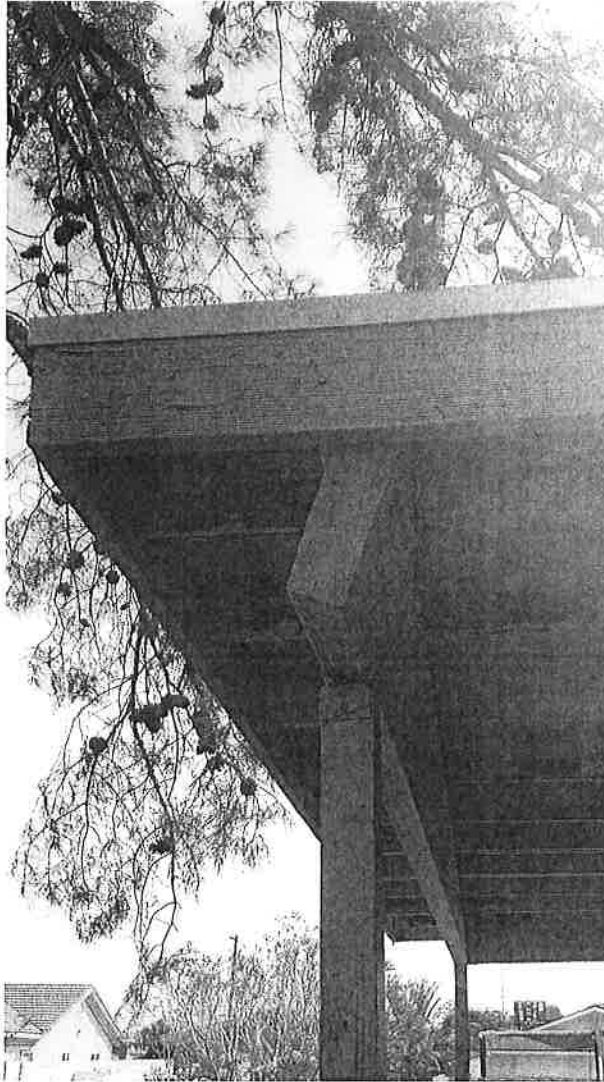
Photo 3 – Twist in Timber and Distorted Column Connection.

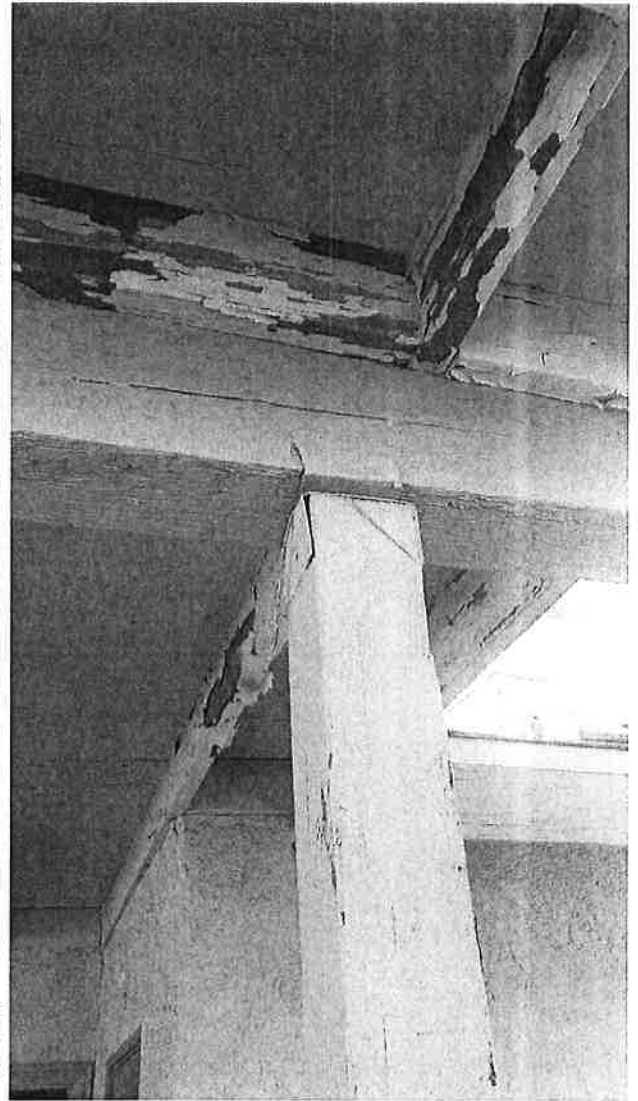
Photo 4 – Closeup of Column Connection.
